III. PROPOSED PROJECTS FOR CONSTRUCTION YEARS 2017-2020

PROPOSED PROJECTS FOR YEARS 2017-2030
 ANAN WILDLIFE OBSERVATORY MASTER PLAN

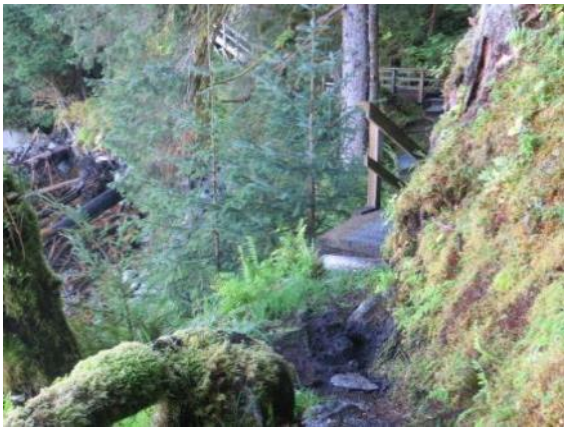
2. **Recreation Cabin to Steep Turn (see image on left):**

Excavate towards the rock on the uphill side of the trail to widen the trail platform by one to two feet as available. The area with the narrow trail and steep drop off extends about 16 feet. Evaluate the structural options to use the bedrock as a footing for a lumber structure that will contain the gravel trail and support the railing. Extend the trail and railing for 16 feet. Widen trail to 30 to 36 inches. Construct a guardrail as well as handrail on the existing staircase.

1. **Recreation Cabin Trail to Bridge 1:** Bridge 1 has an old railing built of log posts and rails. The railing is unstable and wood is decayed.
2. **Recreation Cabin to Steep Turn:** After ascending a flight of seven steps with a handrail, the trail reaches a narrow level area adjacent to a large rock on the left. The trail turns abruptly and traverses an area with a steep exposed drop off on the right. There is no handrail. The area with the narrow trail and steep drop off extends about 16 feet.

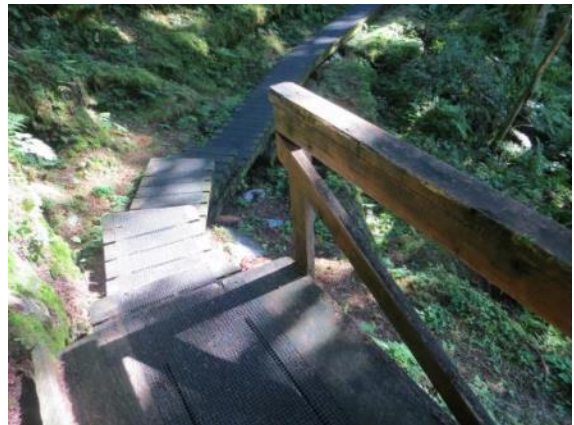
3. **Salt Chuck Overlook to trail transition on east end (see image on right):**

Develop a smooth transition from the overlook by providing a flared landing at the end of the bridge that transitions into a flight of five evenly spaced stairs with equal risers. All will be constructed of lumber. The landing will transition from the width of the overlook to the width of the staircase at 36 inches. There will be a guardrail on the landing and a handrail along the steps.

On the flat section, build a log retaining structure to support a 30 inch wide gravel trail, with a ditch on the uphill side and add two (or more) 18 inch culverts to convey water that may seep from above. At the area where the tree overturned, use the site boulders to support the side of a gravel trail. The area will need rock fill and base course, and a couple of stone steps. Transition up to meet the existing boardwalk. Smoothly angle the gravel trail back to 24 inch trail width to match that already existing.

3. **Salt Chuck Overlook trail transition on east end:** The new Salt Chuck Overlook is planned to tie into the existing boardwalk. At this location there are awkward angles and the trail narrows quickly. It descends about five steps, and then traverses a flat narrow shelf for about 45 feet. At the next location, a tree has overturned, leaving boulders exposed adjacent to the disturbed trail. It ascends several steps through here to arrive at an area of flat boardwalk. This area poses a hazard for visitors who have just arrived and are descending from the new widened overlook.

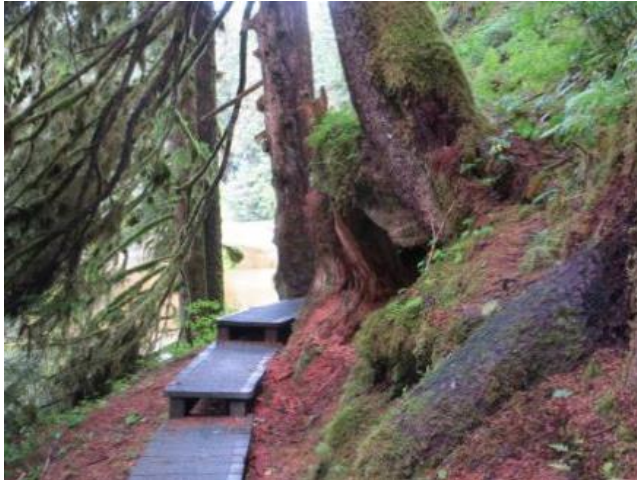
4. “Pinch Point” reconstruction

At the **pinch point**, broaden views by removing vegetation around the tight corner while maintaining slope stability.

4. **“Pinch Point” reconstruction:** There is a pinch point on the trail shortly after rounding the Brown Bear Cove bay area. It is a blind corner with very limited sightlines, especially approaching from the opposite direction. There has been a serious bear encounter here.

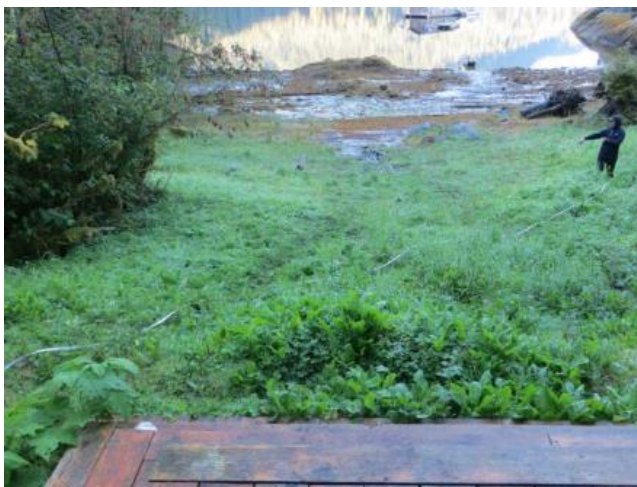
6. Trail Access to Recreation Cabin:

A new gravel trail segment from the high tide line to the right of the cabin steps will be constructed. The trail will begin at the high tide line and end at the corner of the cabin steps. On the short steep section below the cabin, five wide, gentle stone (or wood framed, gravel filled) steps will be installed and a gravel landing area will be constructed at the corner of the cabin steps. This gravel trail will facilitate transport of gear to and from the cabin while reducing impacts to vegetation. The gravel trail will be 48 inches wide and the landing will be 36 inches wide by 60 inches long on each of the two sides of the steps. This gravel trail will facilitate transport of gear to and from the cabin while reducing impacts to vegetation. The invasive plants will be controlled.

6. **Trail Access to Recreation Cabin:** Visitors arriving by boat, access the Recreation Cabin from the beach. However, there is no formalized route. The upper section of the access area is becoming worn and eroded in two informal trail locations. There are also many invasive plants in the area.

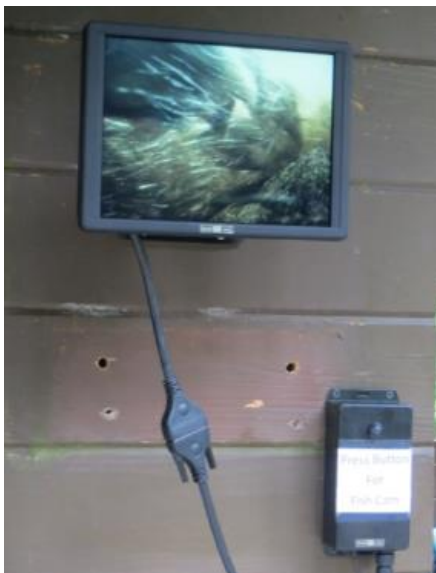
Example of screen for fish videocam installed on the wall of the Anan Wildlife Observatory shelter.
